# SBM Sprinkler Save 12/12/2011

On Monday night 12/12/11, at 7:09 pm SBM Fire responded to a fire at Interpol Laboratories located at 4500 Ball Road. The original call came in as a waterflow alarm. While enroute police on the scene reported that there was smoke in the building and it appeared that sprinklers had activated in the rear of the building. The call was then upgraded to an All Call – Structure Fire response. SBM Fire arrived on the scene and found light smoke in the office portion of the building. A side door was opened into the shop area where heavy “cold” smoke was found and the sprinkler system was operating. There was no visible fire, the sprinkler system had knocked down the fire and had it contained to a racking unit. The first arriving engine was assigned to stretch a line into the building and locate the fire. They made entry and reported that the fire was out and they only had a couple hot spots. The sprinkler system was shut off, the hot spots were extinguished and the building was cleared of smoke. The cause of the fire was improper storage of materials that had been used in a process earlier in the day, which were still hot and placed too close to combustible

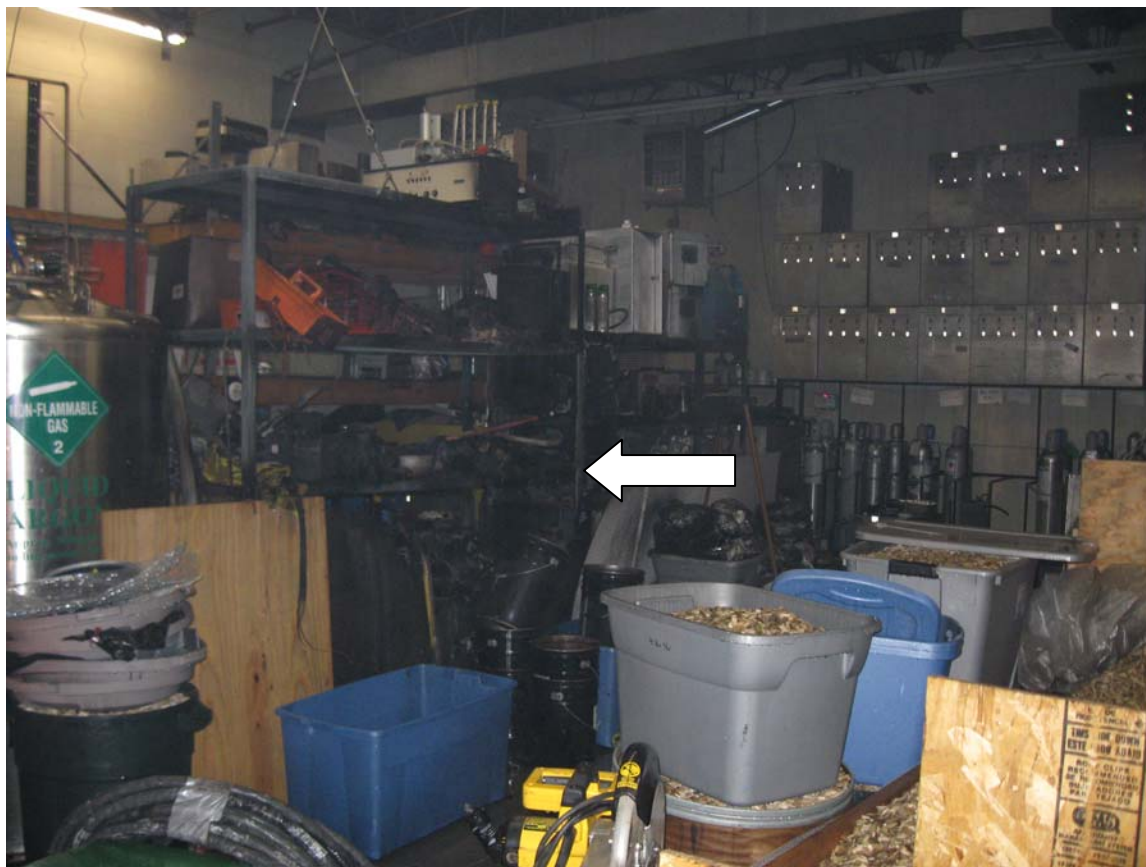
**Figure 1 – Fire was located on the other side of this racking.**

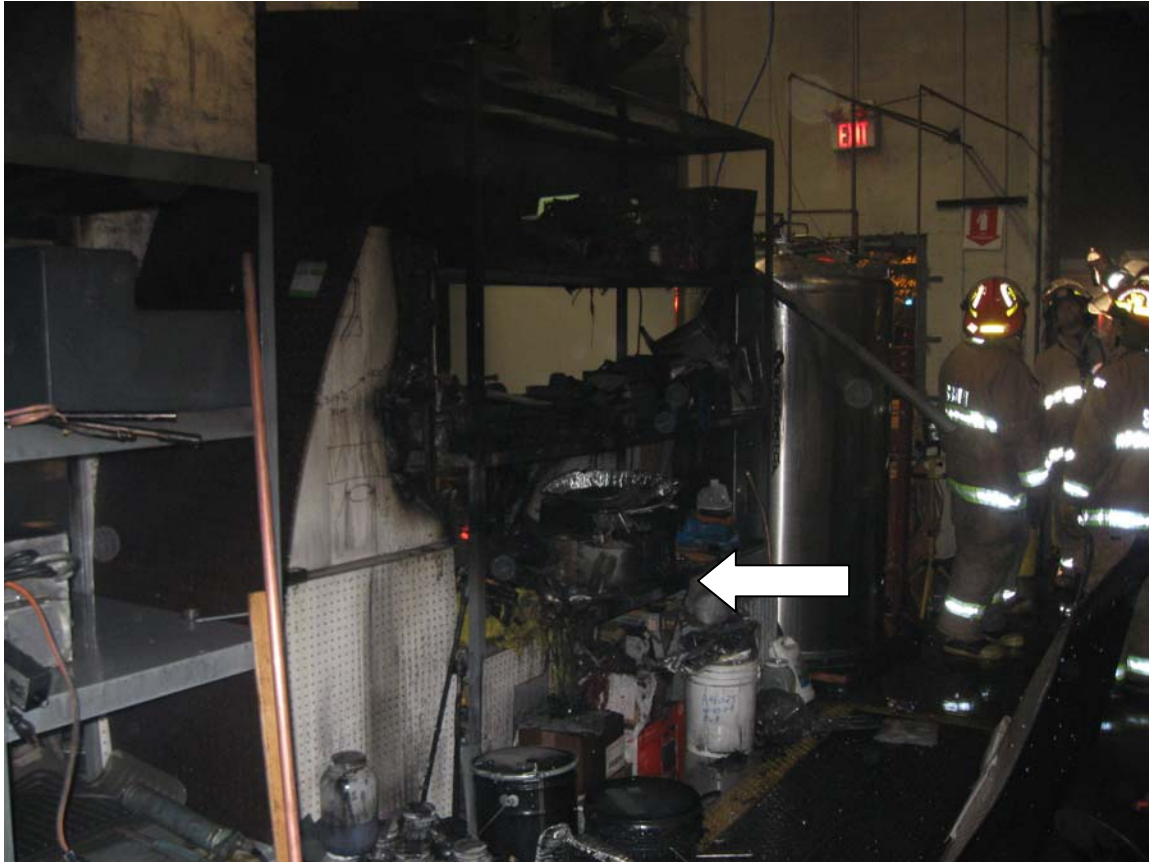
Figure 2 – Location where fire started. Three sprinklers above this location activated and contained the fire.

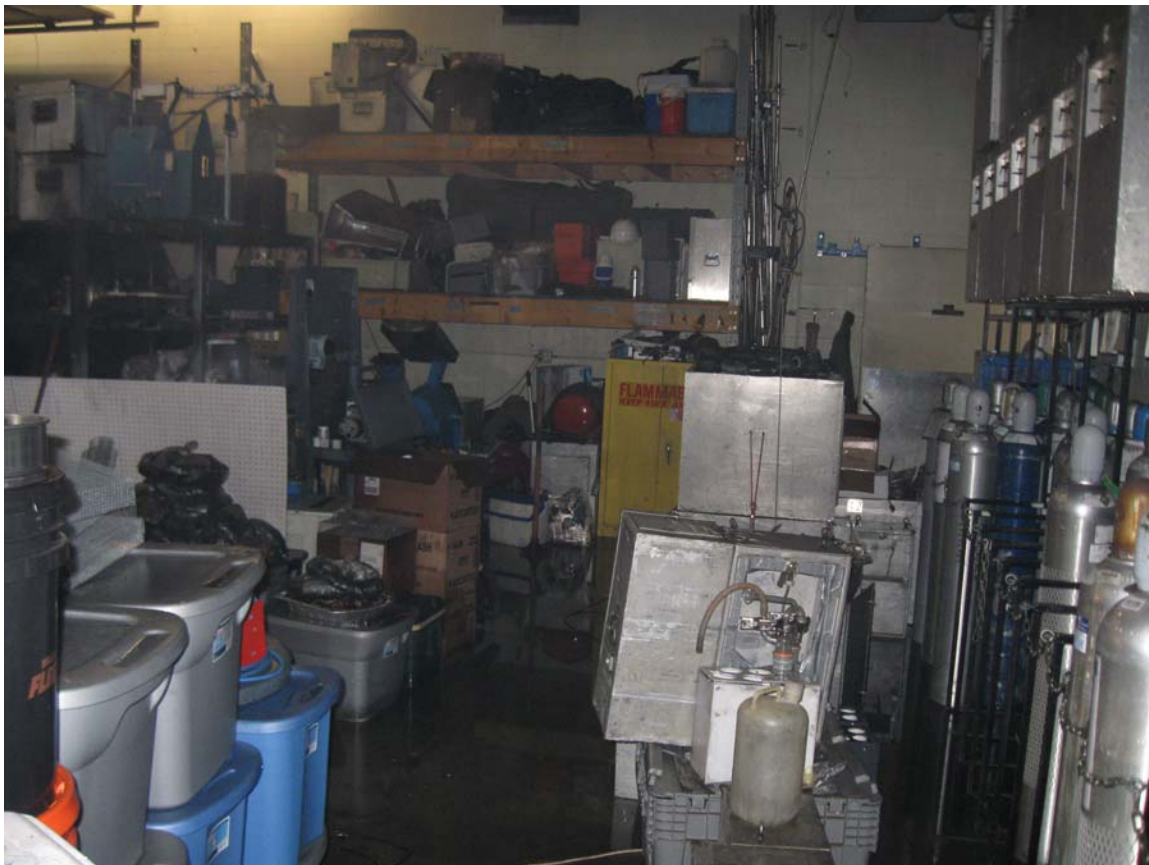
Figure 3 – Rear of the shop area, no fire extension to other items in the shop.

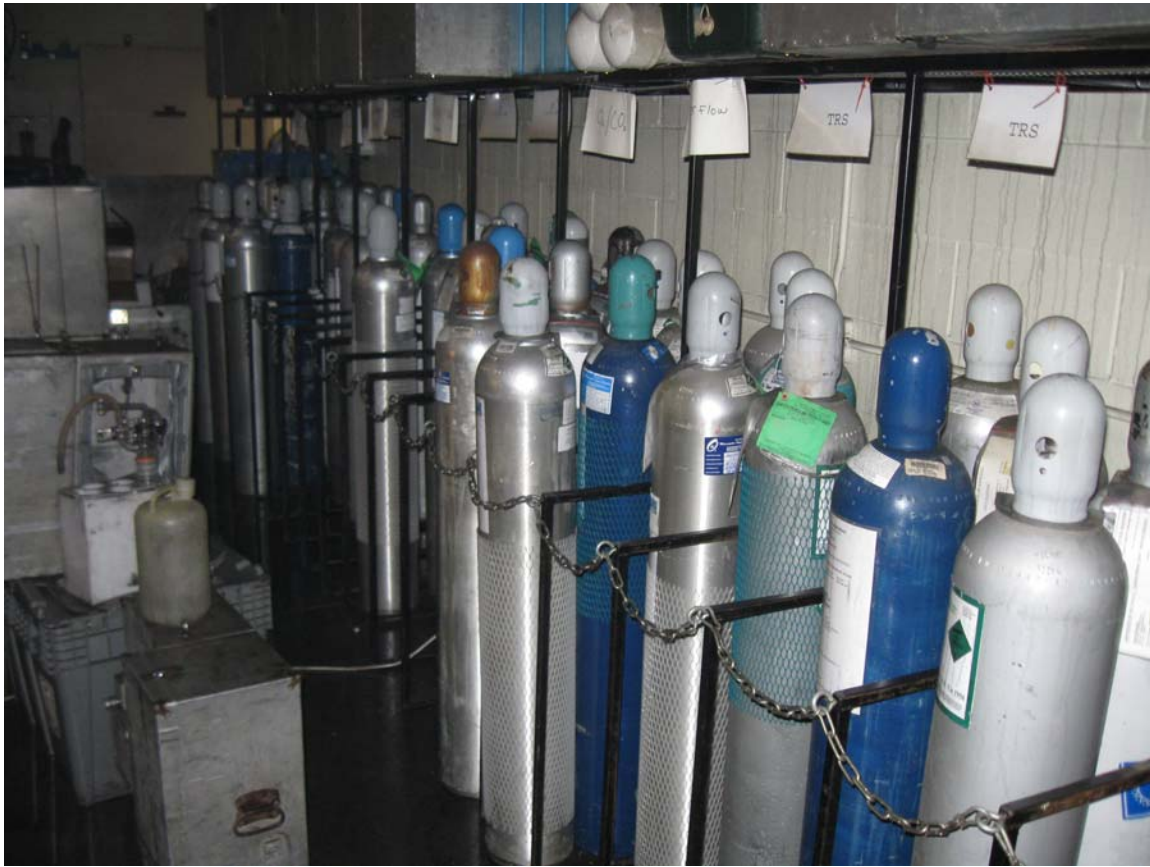
Figure 4 – Compressed gas cylinders in rear of shop. Not affected by the fire.

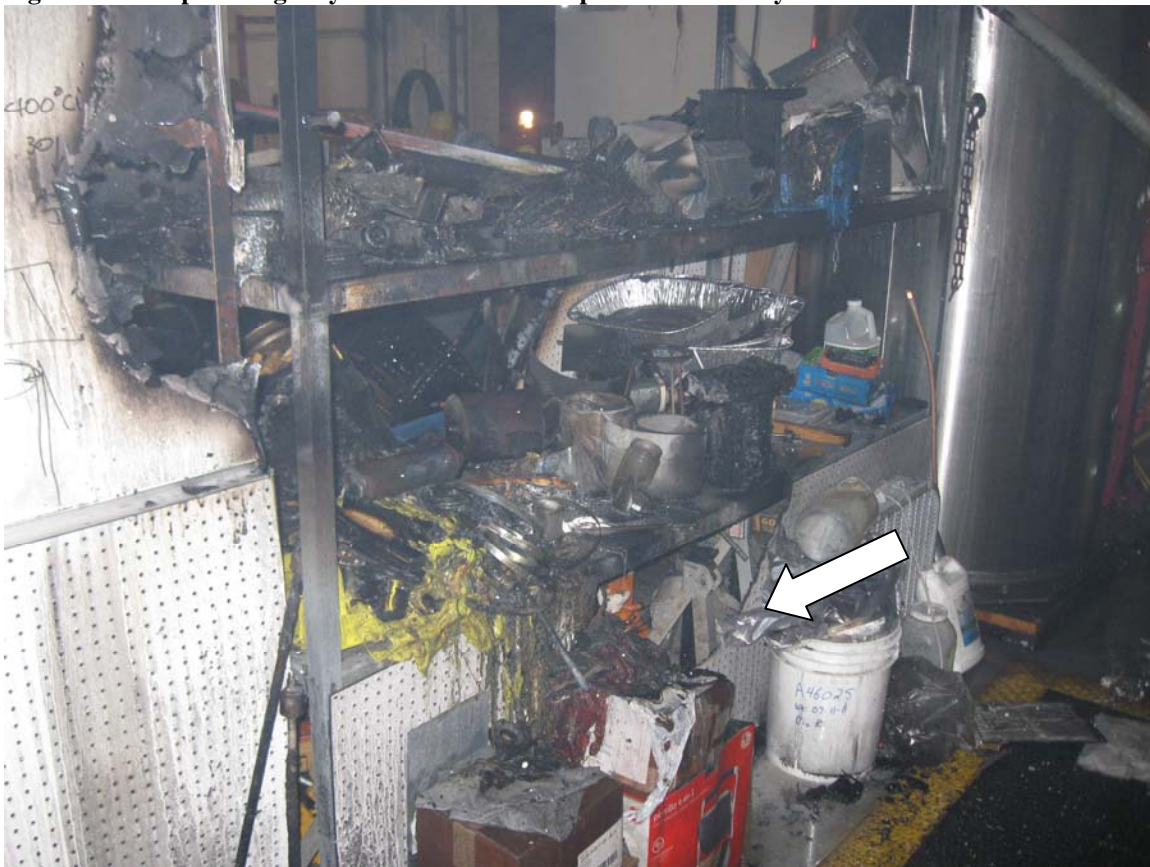
Figure 5 – Origin of Fire

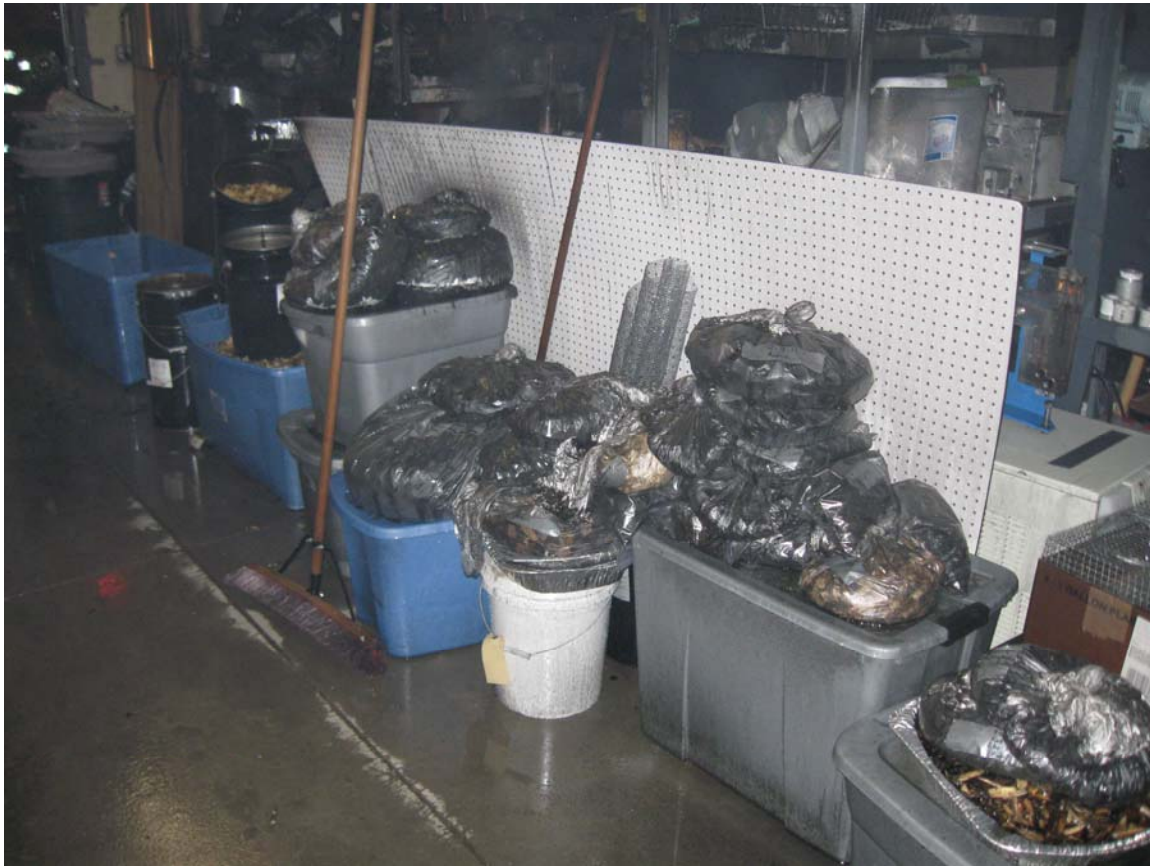
**Figure 6 – Items stored just three feet away were not damaged.**
